Technical Report

October 1971

AD BLAST RESPONSE OF FIVE NFSS BUILDINGS

STANFORD RESEARCH INSTITUTE
Menlo Park, California 94025 • U.S.A.

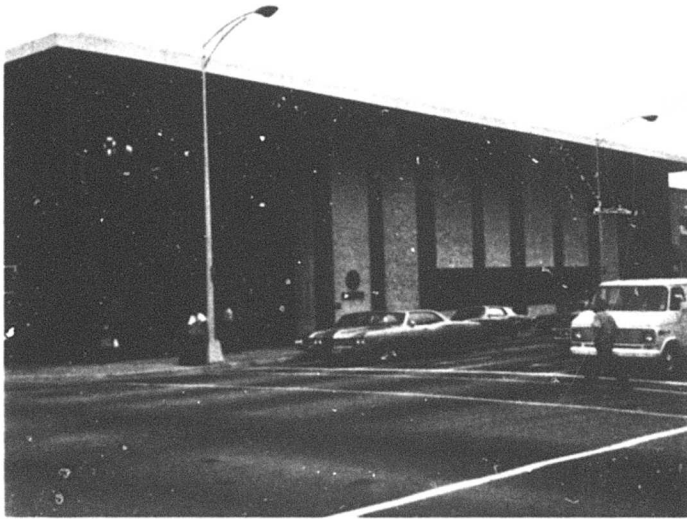
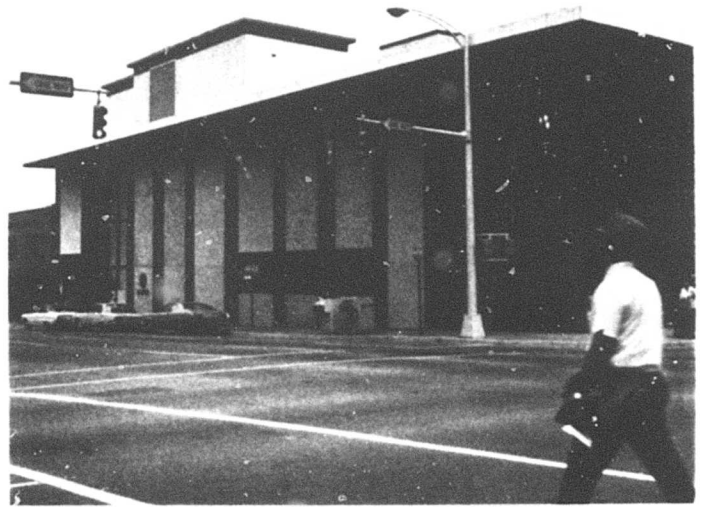
The Greensboro Public Library constructed in 1964, is located at N. Greene and W. Gaston Streets in Greensboro, North Carolina. The Library consists of two stories above ground and two basement levels. The overall height of the building is 33 ft and plan dimensions of 140 ft by 143 ft provide an area of about 17,000 sq ft on the first floor and 20,000 sq ft on the second and basement floor levels. As noted on Figure 2, sides A and B have a minimum window area except for the front entrance. Most of the wall area on sides C and D is shielded by adjacent buildings.

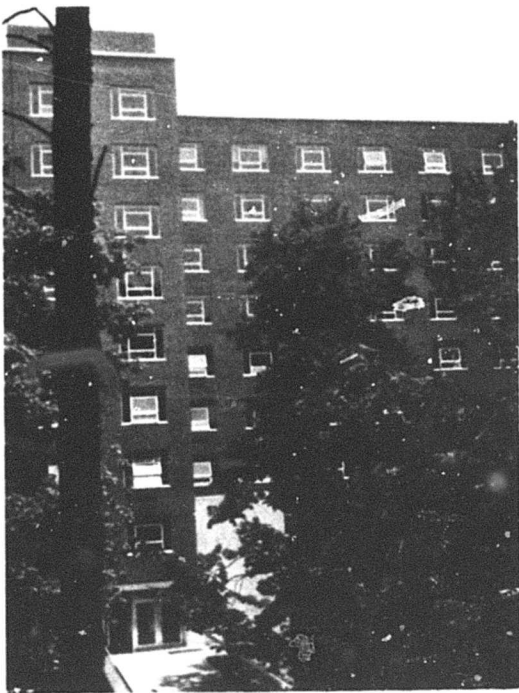
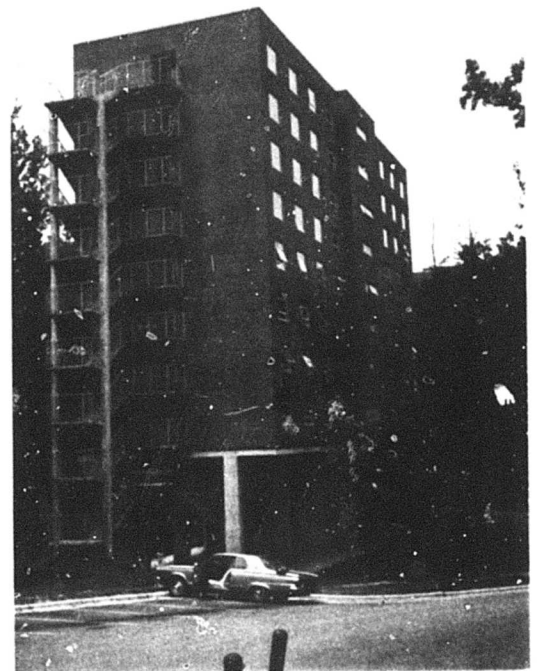
Field Survey Data. During the on-site survey the exterior walls of the Dormitory were classified as nonreinforced concrete block panel walls with brick masonry veneer. The concrete block on the upper floors was

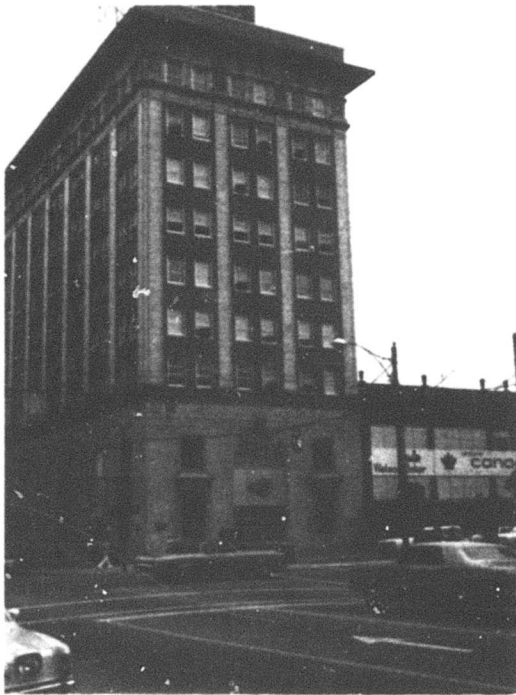
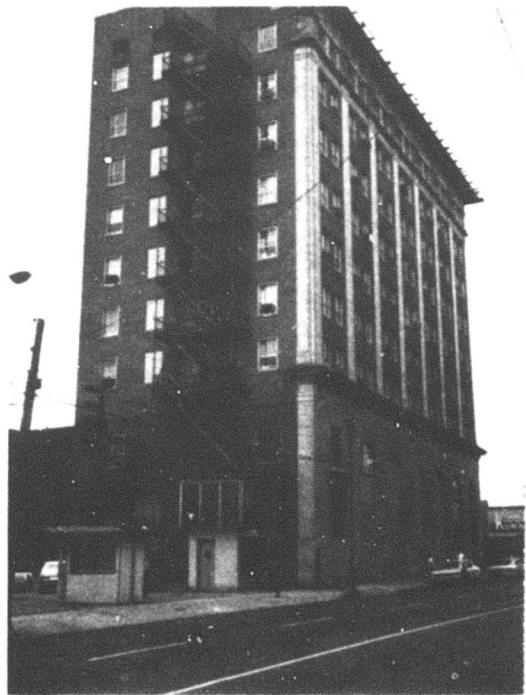
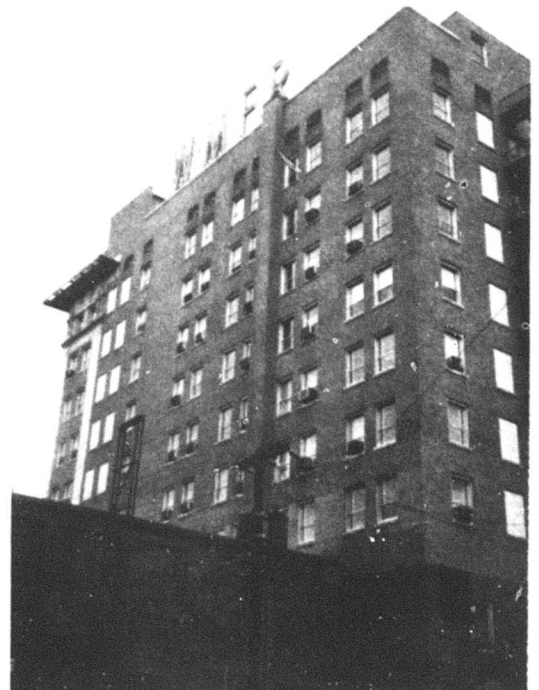
The North Carolina National Bank, constructed in 1922, is located on South Main Street, High Point, North Carolina. The building consists of 8 stories and an unexposed basement; there is a mezzanine between the first and second stories. The overall height of the building is about 110 ft and plan dimensions of 50 ft by 115 ft provide an area of 5750 sq ft on each floor level. Figure 9 shows the exterior walls and

The exterior walls on sides A and B of the first story are 17-in. thick and are constructed with a granite veneer and a brick backing. On sides C and D of the first story the walls are generally 17-in. thick solid brick. On the upper stories the walls are constructed with a 4-in. thick brick veneer and an 8-in. thick terra cotta backing. As can be noted in Figure 9, the exterior column lines on the upper stories of sides A and B are faced with a granite veneer. For all exterior walls the facing is continuous over the frame members and the backing is inset in the frame. The interior partitions on the first story and mezzanine are constructed with unreinforced terra cotta, either 3- or 6-in. thick. On the upper stories the interior partitions are mostly 3-in. unreinforced terra cotta. The partitions are nonload bearing and have numerous openings that have been filled-in with light wood paneling.
